Manhole Inspection Summary

Manhole # S25A__015MH

Insp Date: **8/21/07 11:36 AM**

Location Address: **626 CARROLLTON AVE**

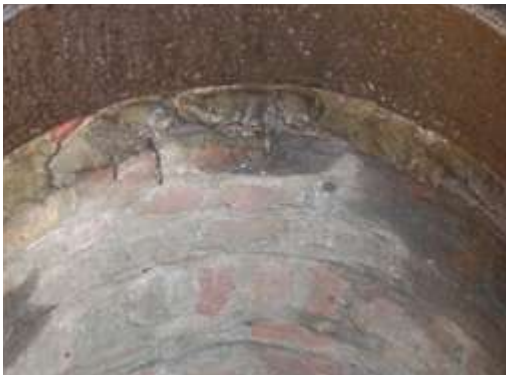
Defect 2

Condition: ☐ Sound ☐ Cracked ☐ Root Intrusion ☐ Loose Brick ☒ **Deteriorated**

Infiltration: ☐ None ☐ Joint ☐ Cracks ☐ Mortar ☐ Roots ☒ **Wall**

DETERIORATED AND INFILTRATION
CHIMNEY

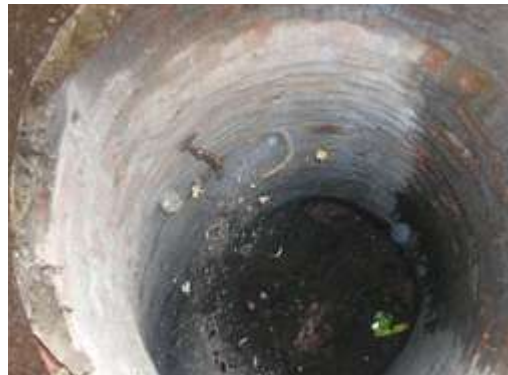
Defect 1

Count: **0** Missing: **5** ☐ Corroded

ALL MISSING STEPS

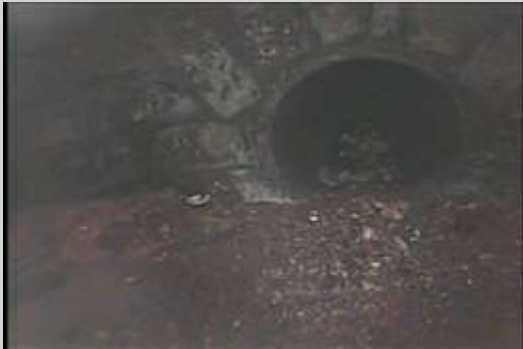
12 O'Clock Outflow

8 in. Circular Gravity Sewer
Pipe Out @ 12 O'Clock

Deposits: ☐ None ☐ Mud ☐ Sludge ☒ **Debris** ☐ Grease

Silt Depth: **1** (in.) Deposits Extent: **Light**
